DEEP HOLLOW DAM  
NDS ID NO. PA-00549  
DER ID NO. 40-3

PENNSYLVANIA GAS AND WATER COMPANY  
PHASE I INSPECTION REPORT  
NATIONAL DAM INSPECTION PROGRAM

Prepared by  
GANNETT FLEMING CORDDRY AND CARPENTER, INC.  
Consulting Engineers  
Harrisburg, Pennsylvania 17105

JUNE 1978

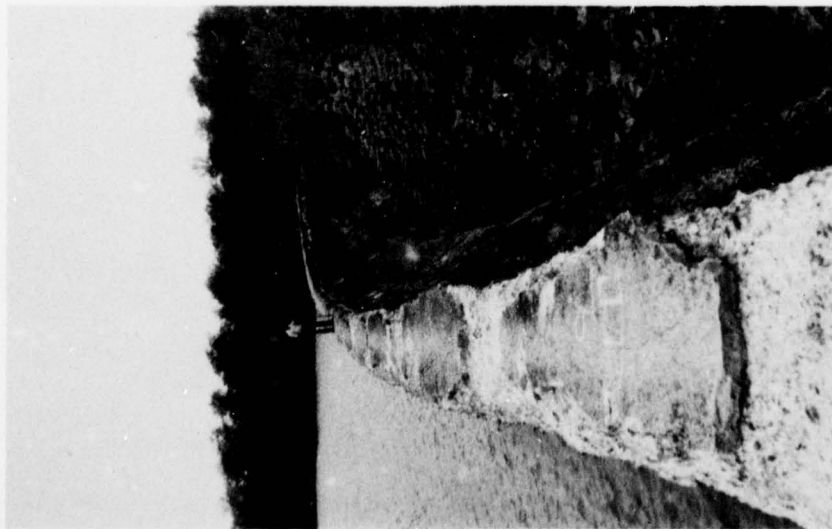
(1) The concrete of the dam was in various stages of deterioration. About 20 percent of the top of the curved portion of the dam was disintegrated to a 3-inch depth (Photographs C, D, and E). Almost all of the top of the two straight sections of the dam was disintegrated to a depth of about 3 inches (Photographs G and H). In general, about 80 percent of the downstream face of the left half of the dam was scaled to an average depth of 2 inches (Photograph D). The downstream face of the right half of the dam was scaled and disintegrated over most of its surface to an average depth of 10 inches (Photographs C and K). A more detailed description of the condition of the concrete on the downstream face is presented in Appendix B. The exposed portion of the upstream face of the dam had deterioration of a more local nature (Photographs A and B). About 10 percent of the exposed surface had scaling, spalling, or disintegration to an average depth of 6 inches. However, some areas were more deteriorated. At the right end of the curved section of the dam, a 25-foot reach was disintegrated to a depth of about 18 inches (Photograph F). In this reach a 2-inch diameter cable that was embedded in the concrete is exposed. The concrete deterioration is generally more advanced at the construction joints, particularly near the top of the dam.

C. Crest and Downstream Face of  
Curved Concrete Gravity Section  
Near Right End

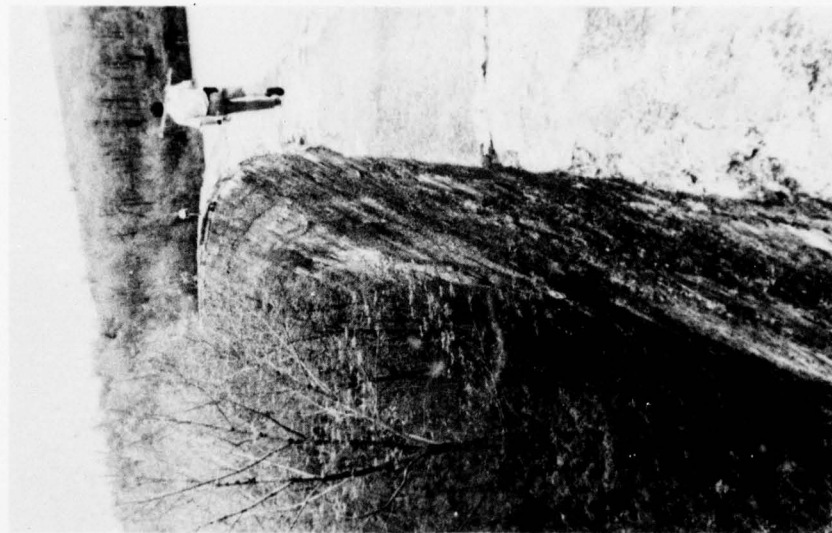
D. Crest and Downstream Face of  
Curved Concrete Gravity Section  
Near Left Abutment

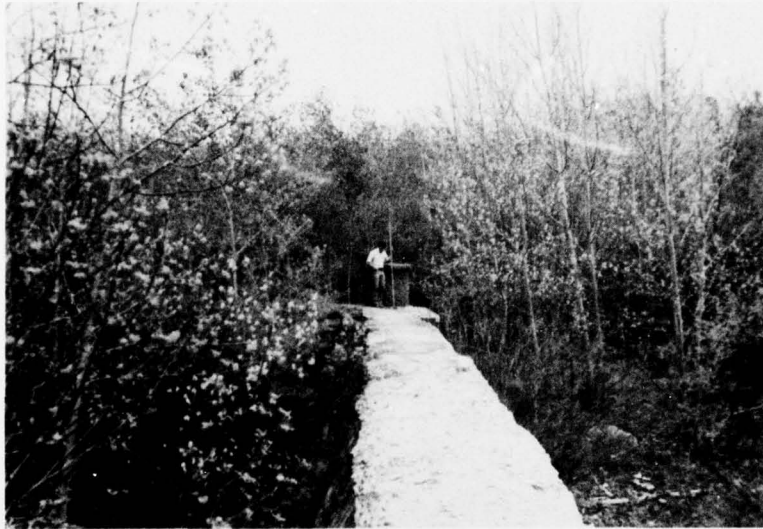
E. Right End of Curved Concrete Gravity Section.  
Spillway Approach Channel is in Background  
at Center.

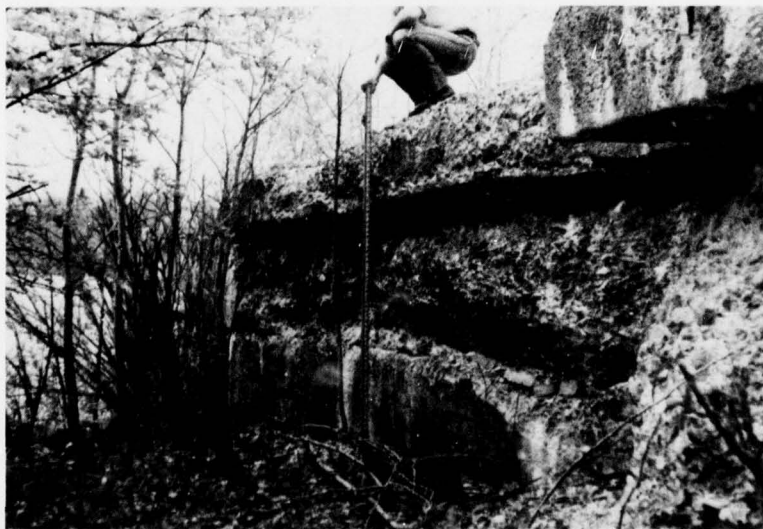
F. Concrete Disintegration Along the Upstream Face of  
the Curved Concrete Gravity Section  
at Right End

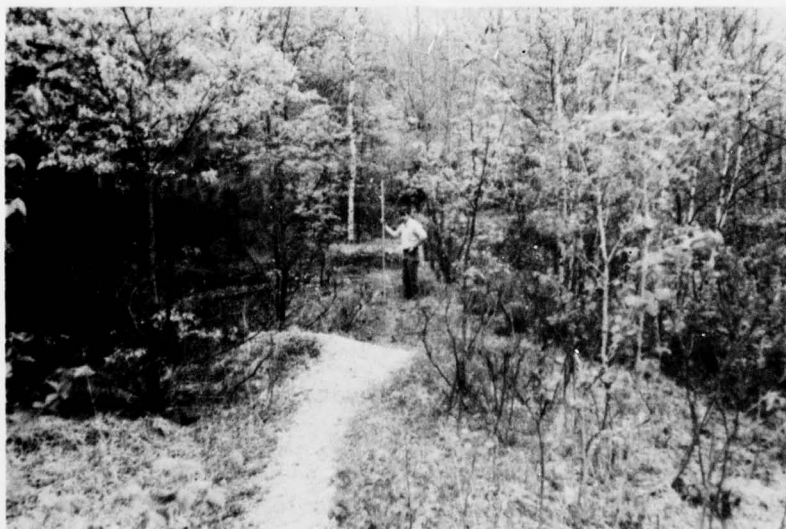
(1) The spillway crest is at the original ground level. The concrete on the crest was cracked and uneven, and one section was missing (Photograph H). The spillway approach channel was completely overgrown with 2-inch to 4-inch diameter mixed hard woods (Photographs E, G, H, and I). The spillway discharge channel was irregular and overgrown with heavy forest (Photograph H). The outlet channel was not lined, but several rock outcrops were visible.

H. 32-Foot Wide Spillway.  
Spillway Approach Channel is on Right.  
Spillway Outlet Channel is on Left.

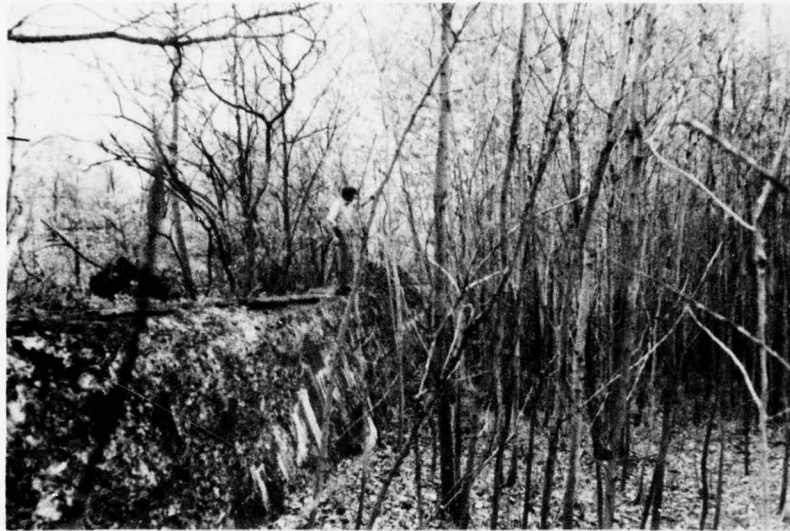
(3) The downstream half of the railroad embankment retaining wall had scaling over about 75 percent of its exposed face to an average depth of 2 inches (Photograph I). The upstream half was generally in good condition except that near the upstream end a horizontal construction joint near the top of the wall was weathered to a depth of 4 inches, and about 0.5 inch of differential

movement was measured. Concrete at construction joints was generally more deteriorated than the other areas, and several small trees were growing in the construction joints.

(3) The condition of the railroad embankment retaining wall is not very significant. It has not yet deteriorated to the extent of being considered unsatisfactory, but some maintenance is needed. Continued growth of the trees in the construction joints will cause accelerated deterioration.

I. Railroad Embankment Retaining Wall.  
Spillway Approach Channel on Right.

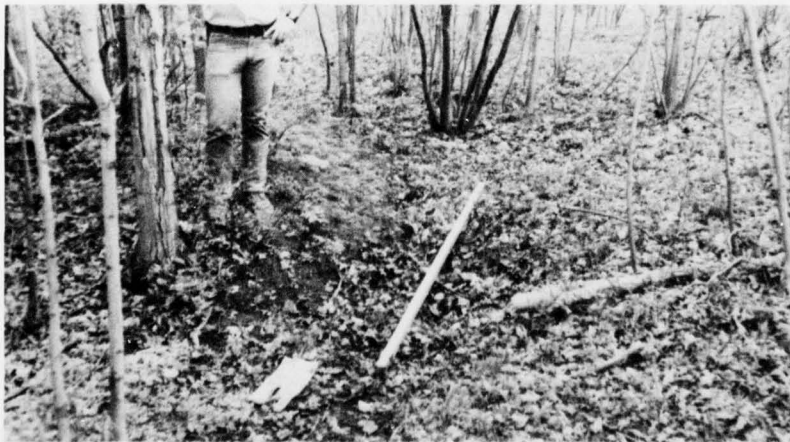
J. Wet Area Downstream from Dam  
Located About 600 Feet from Left Abutment.

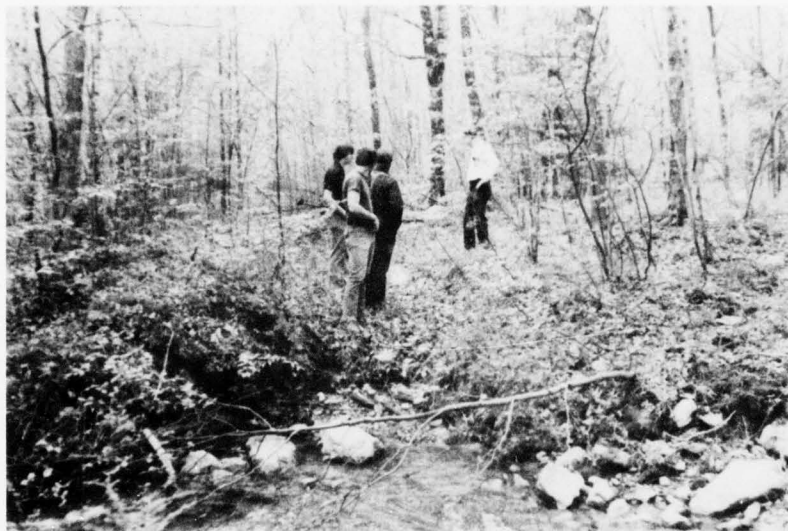
M. Intake Area of Abandoned Flume.  
The Masonry Intake Structure  
Has Been Completely Washed Away.
